**General  
Services  
Administration  
Caribbean Property  
Management Center**

**Parking Garage  
PR0024ZZ**

**Post-Earthquake Assessment**

**STRUCTURAL REPORT**  
**VISUAL INSPECTION OF THE**  
**PARKING GARAGE (PR0024ZZ)**

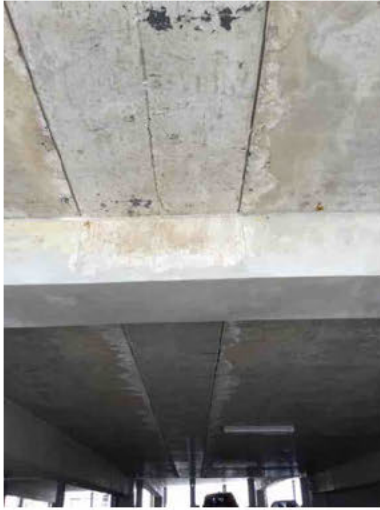
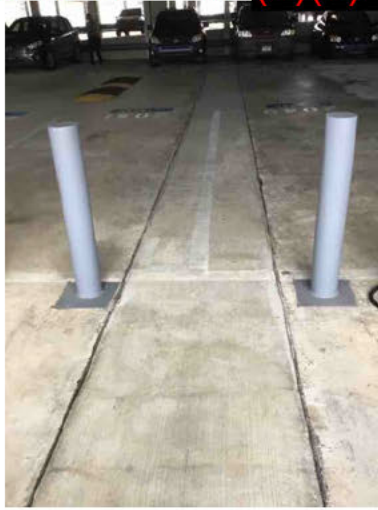
18 1/13/20

Presence of efflorescence at shrinkage strip at lower surface (b)(5)

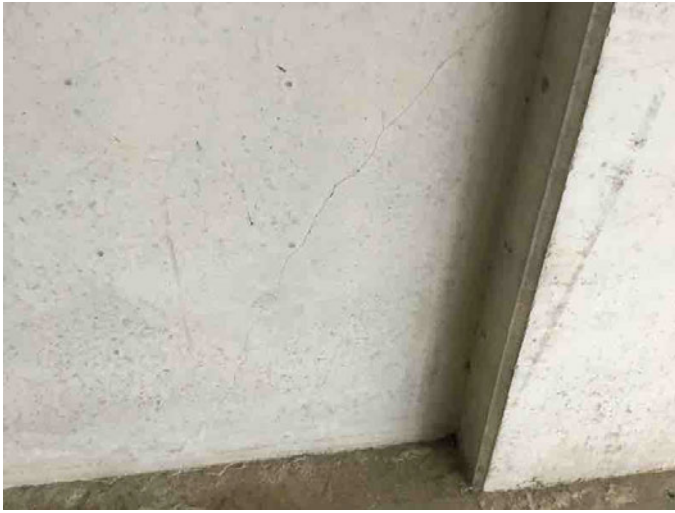
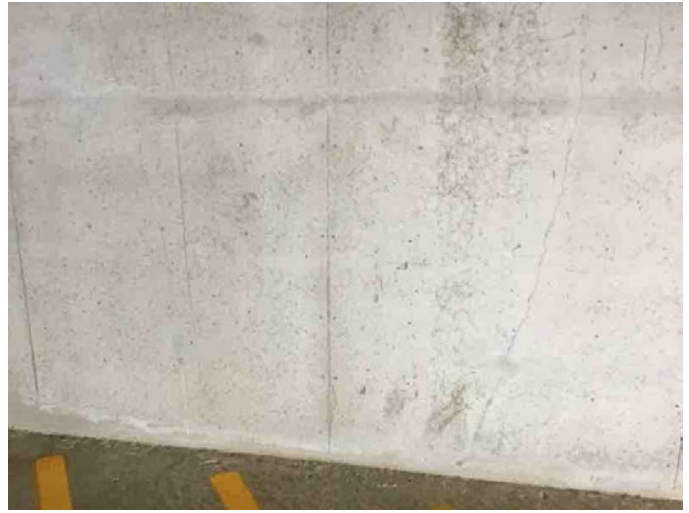
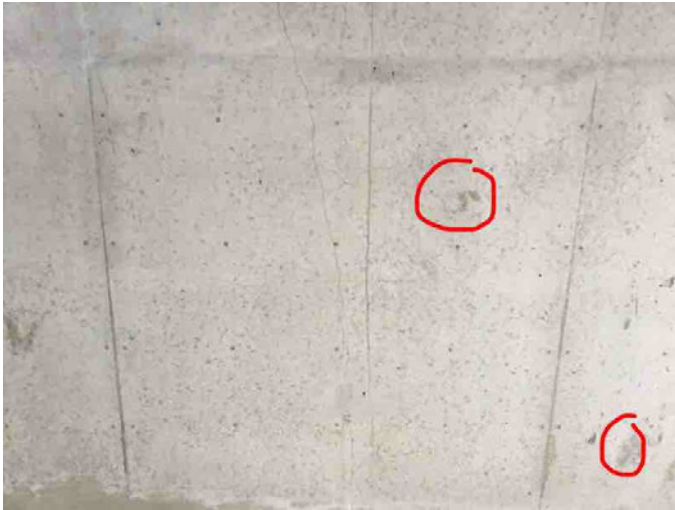
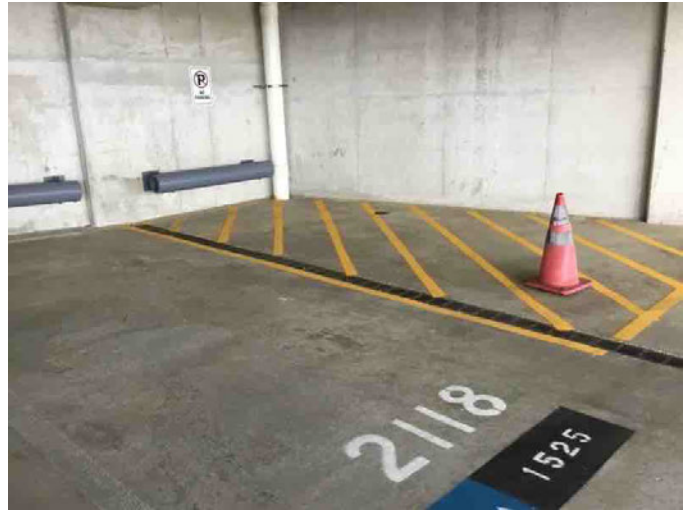
28 + 1/13/20

Dagona har ne cracks on structura wa . Previous defect. (Some cracks appear to be nvest gated due to presence of concrete cores. Od marks on some of them for dent ficat on). Not related w th recent se sm c act v ty.

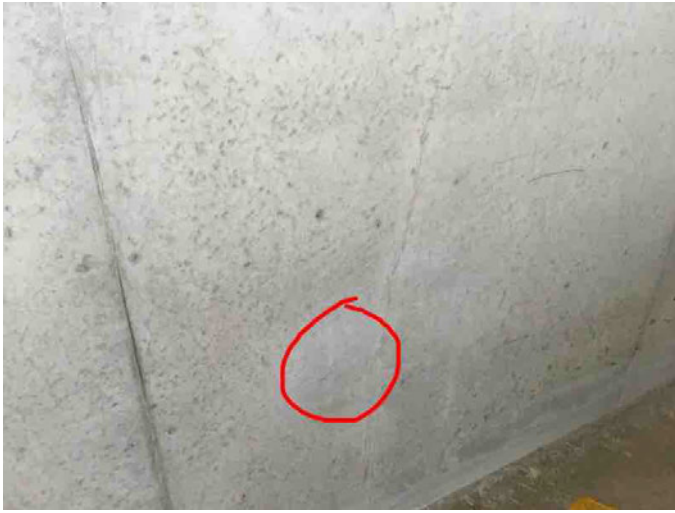
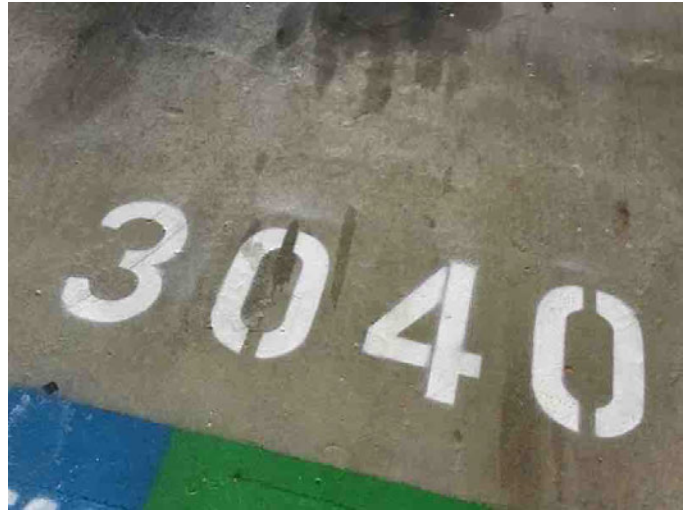
36 + 1/13/20

Dagona har ne cracks on structura wa . Prev ous defect. (Some cracks appear to be nvest gated due to presence of concrete cores. O d marks on some of them for dent ficat on). Not re ated w th recent se sm c act v ty.
